Review Gilcrease Turnpike Wetland Assessment Results

OKRAM TRAINING: DAY 2

Site 1 Assessment Review: Assessment Area

Site 1 Assessment Review: Site Description

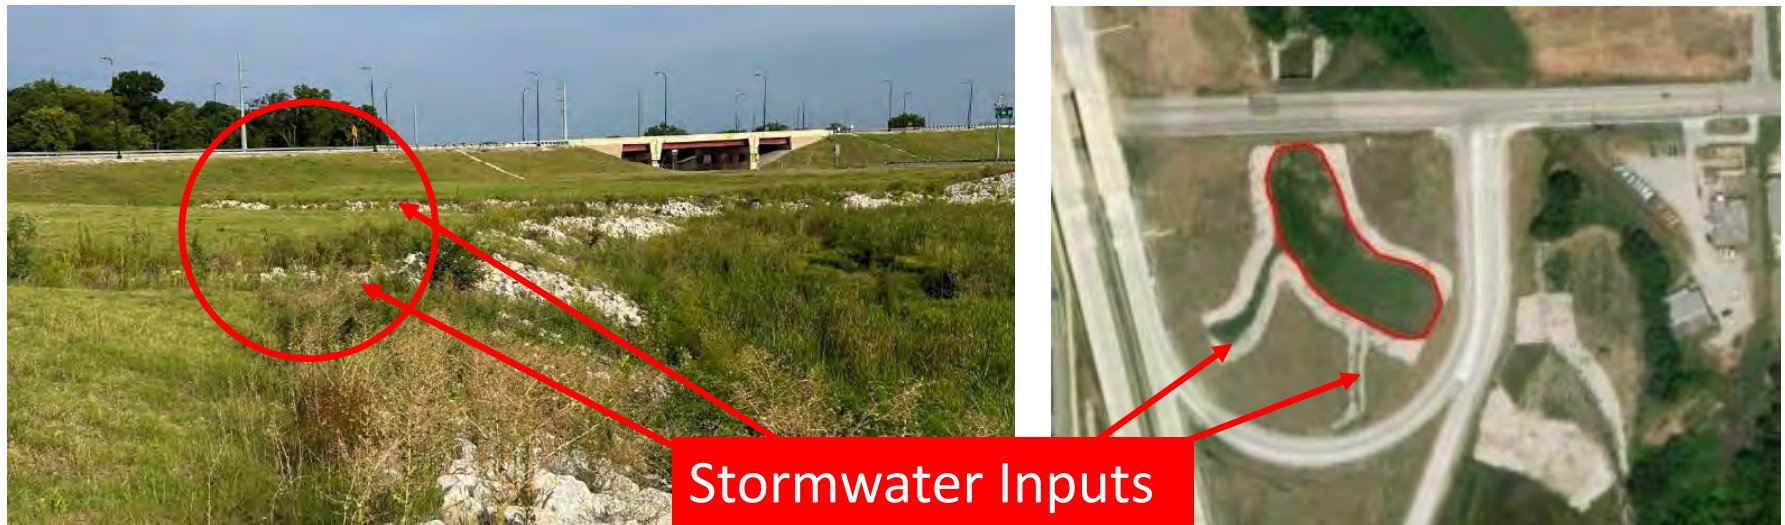
Site 1 Assessment Review: Hydroperiod

- Culvert discharges, ditches, or tile drains in to or out of the wetland
 - Moderate
 - Water enters wetland from culverts, diversions or ditches only during large storm events

Hydroperiod is impacted
 No Indicators of Altered Hydroperiod Present
 AA is not a Wetland

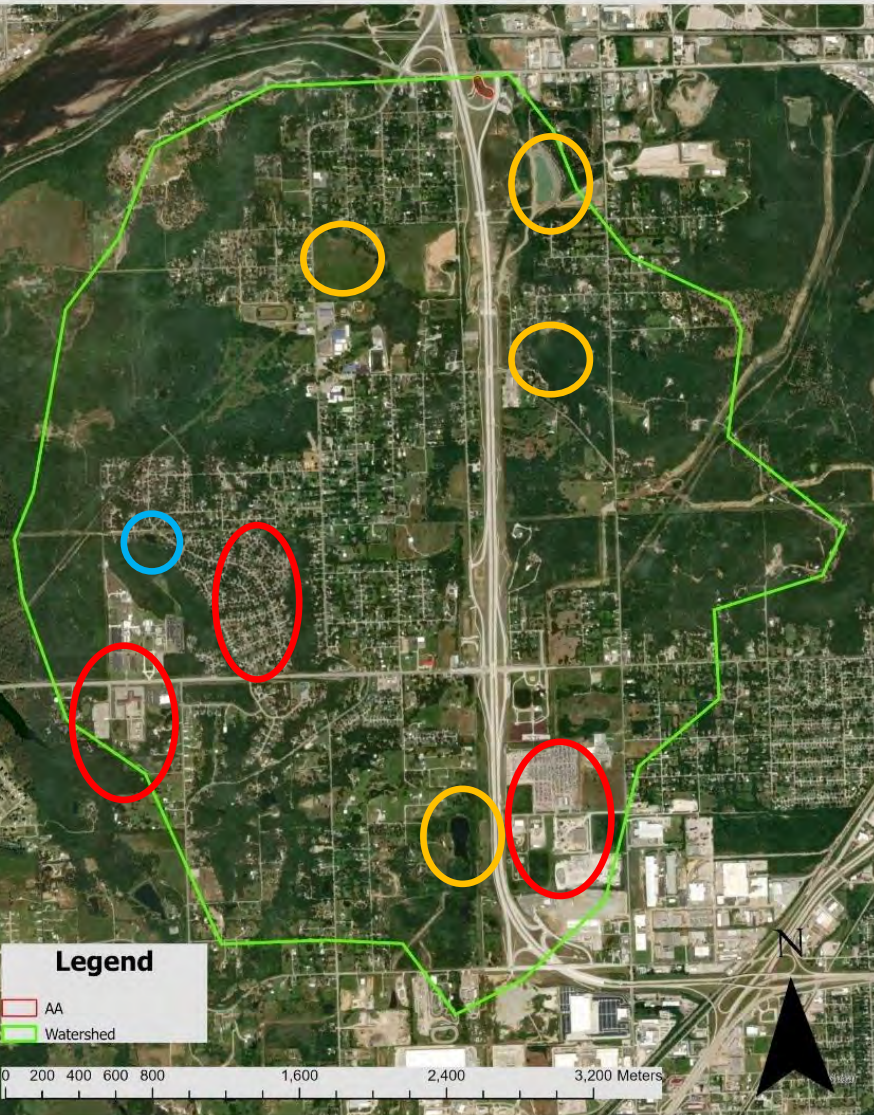
Wetland 1: Watershed

- Watershed is ~3,700 acres
- Upstream Impoundment @ 5,500 meters
- Roughly 700 acres impervious or 20%
- Roughly 2% ponds, 1% dryland ag, 1% excavation, and 1% woody encroachment
- Water Source score of 0.58

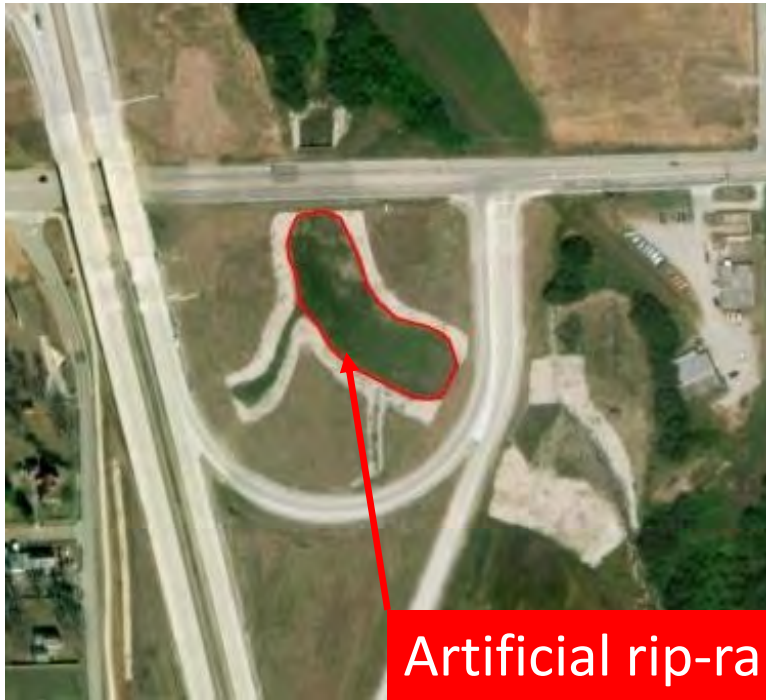
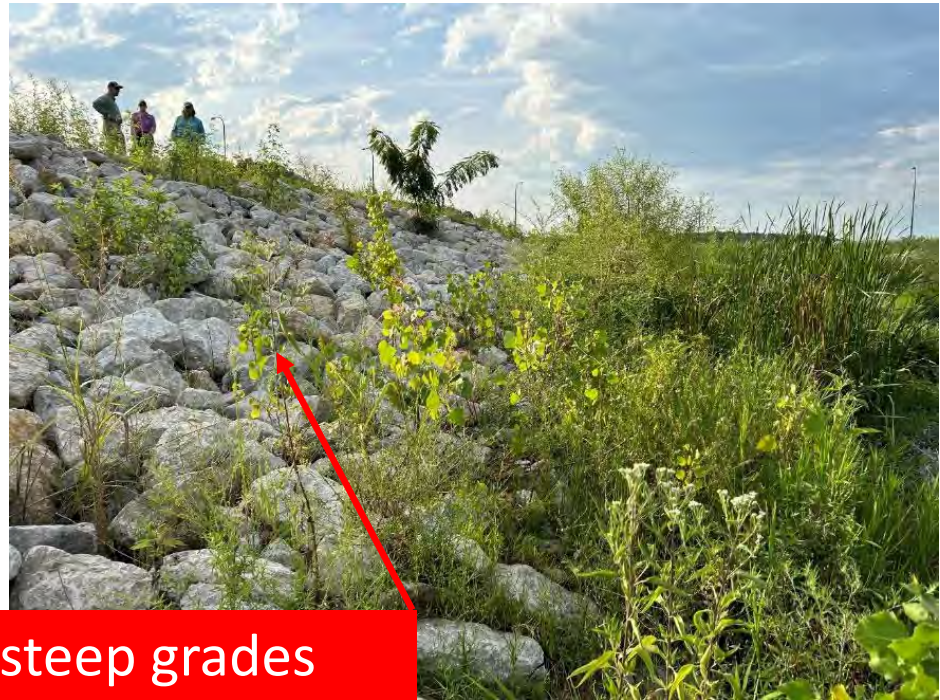
Site 1 Assessment Review: Hydrologic Connectivity

Artificial rip-rap steep grades

Hydro Connectivity = $(100 - \text{altered perimeter})/100$.
 Hydro Connectivity = $(100 - 90)/100 = 0.1$

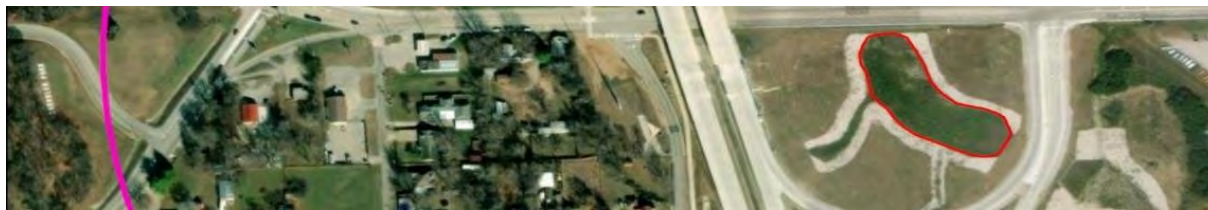
Site 1 Assessment Review: Excess Nutrients and Contaminants

- Residential Runoff and Septic/sewage discharge
- Minor
- Residential dwellings within 200 meters of wetland

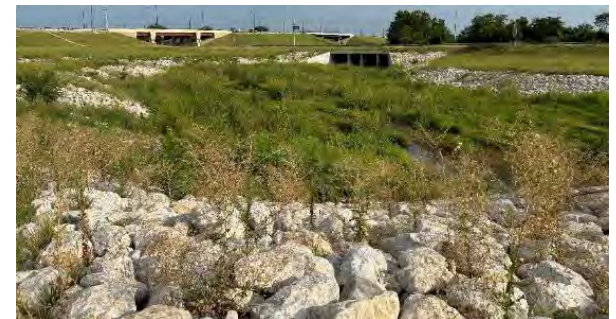
- Stormwater inputs
 - Moderate
 - Stormwater inputs from culverts

Nutrients/Con Score = 1 - (Extent * Severity Weight) = 1 - (1 * 0.25) - (1 * 0.5) = 0.25

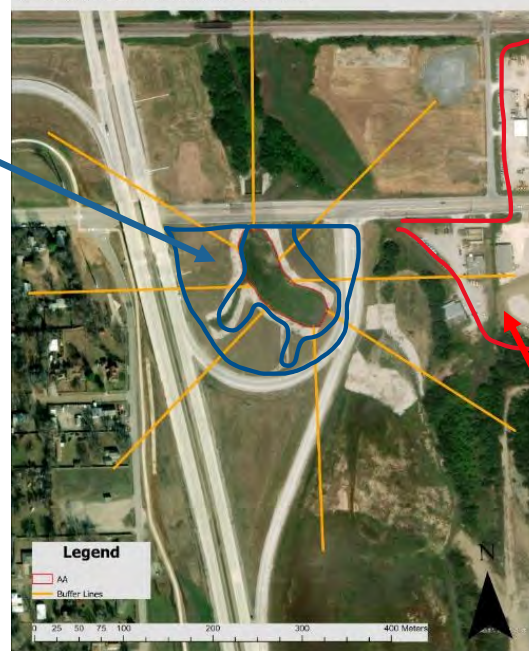
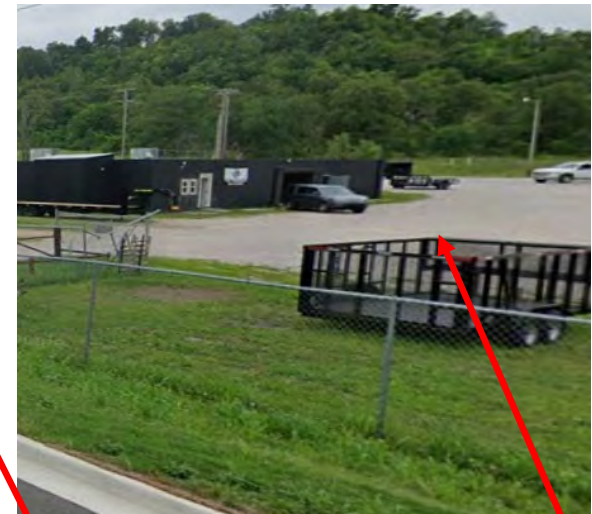
Wetland 1: Buffer Lines

Mowed Lawn directly adjacent to entire AA- low impact

Urban area intersects east transect at 190 m- high impact

- ❑ %Intact = lowest value among:
 - ❑ High impact/250
 - ❑ Moderate impact/100
 - ❑ Low impact/30
- ❑ Transect 3
 - ❑ High impact = $190/250 = 0.76$
 - ❑ Low impact = $0/30 = 0$
 - ❑ 0 is selected for % intact
- ❑ Metric score is average of %intact for all 8 transects

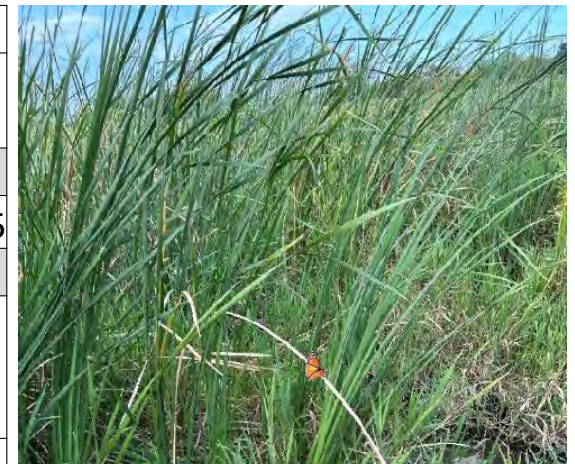
Cattails are a native monoculture at ~60% cover and is recorded as 10% (60-50)

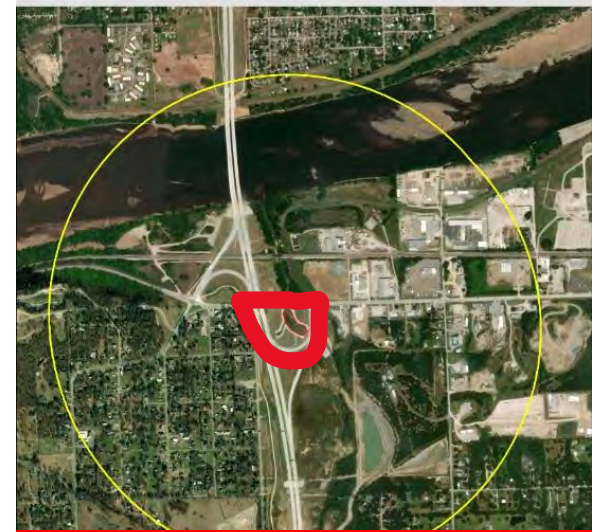
Wetland 1: 1000 meter buffer

Mowed lawn and turnpike limit connectivity to AA (0.5 ha)

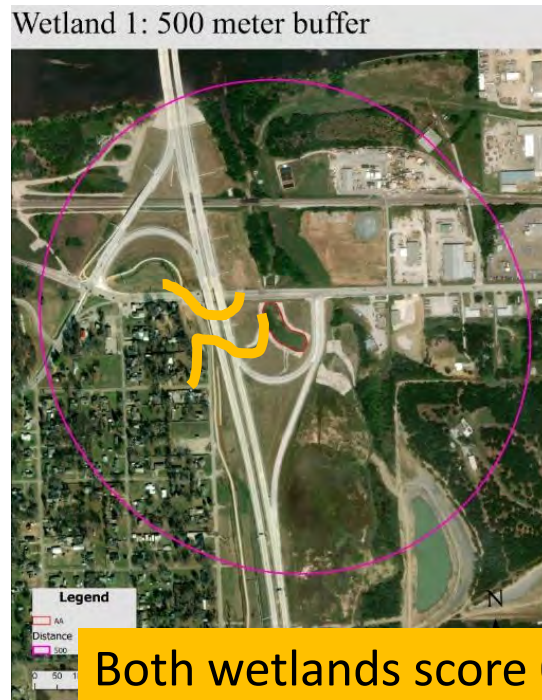
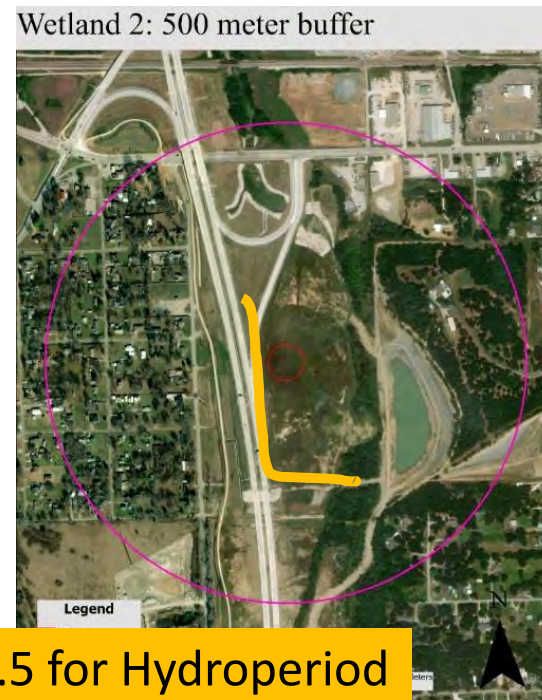
Site 2 Assessment Review: Hydroperiod

Moderate stressor from direct stormwater inputs

Moderate stressor from stormwater inputs into creek which serves as primary water source

Both wetlands score 0.5 for Hydroperiod

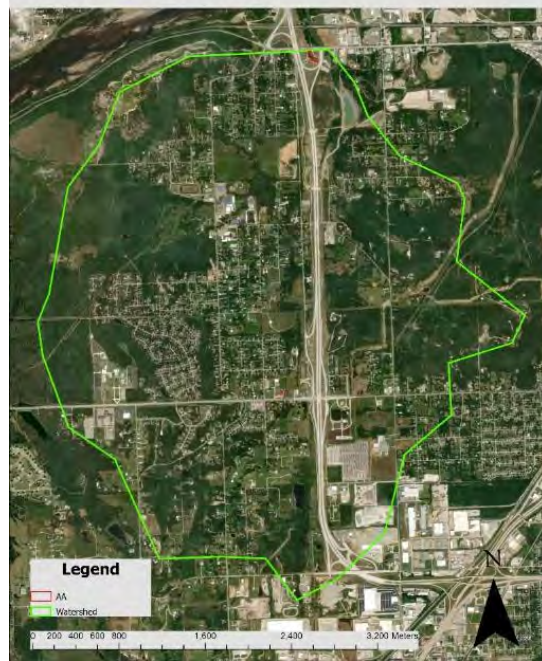
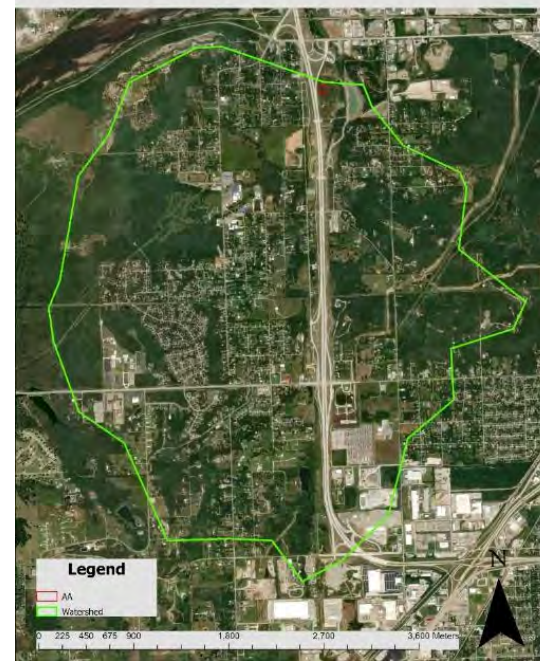
Site 2 Assessment Review: Water Source

Both watersheds nearly identical and score 0.58 for Water Source

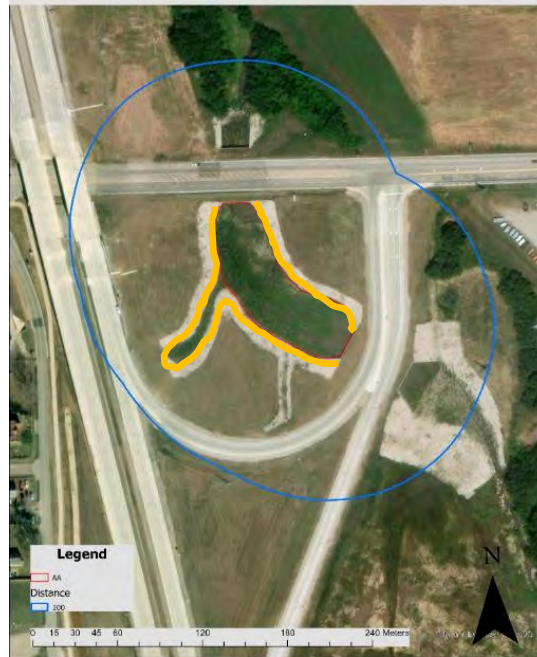
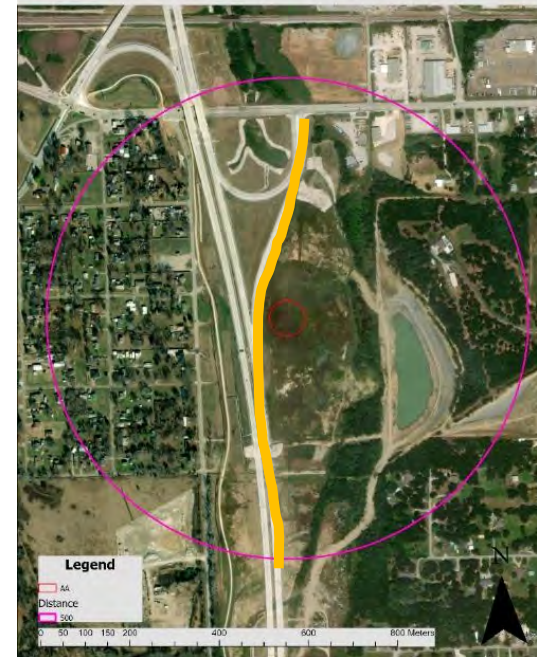
Site 2 Assessment Review: Hydrologic Connectivity

Site is surrounded by artificial steep grades (except culverts) and scores a 0.1

50% of wetland boundary is adjacent to steep road grade and scores a 0.5

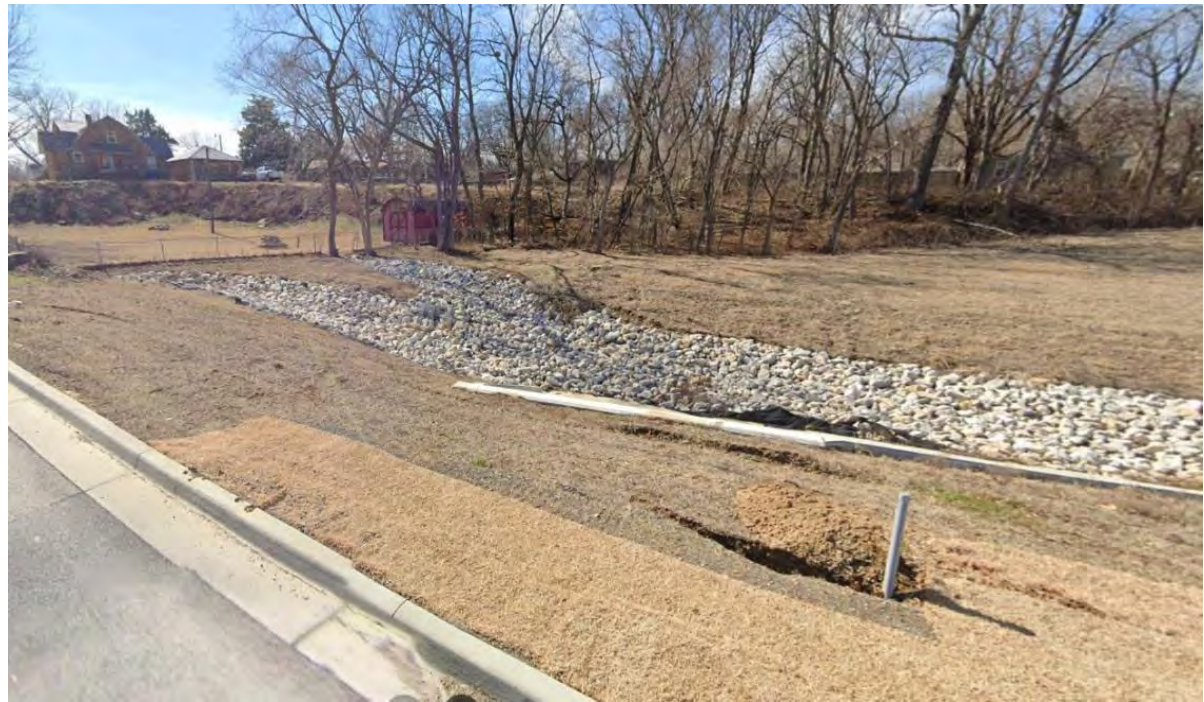
Site 2 Assessment Review: Excess Nutrients and Contaminants

Both sites have residential and stormwater inputs of nutrients and contaminants and score 0.25

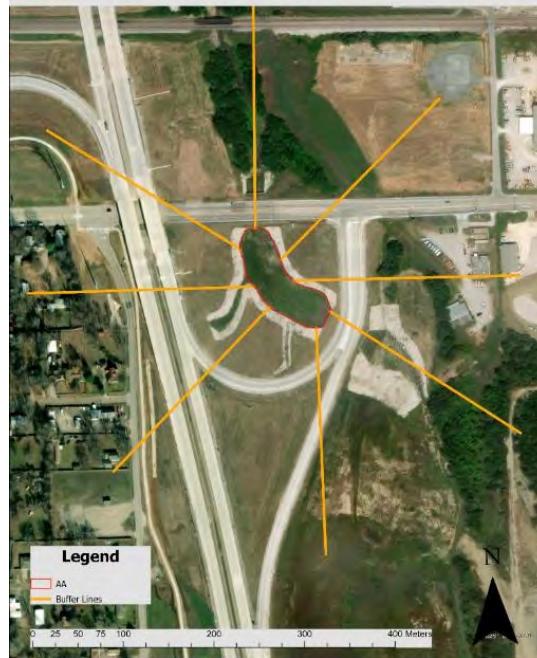
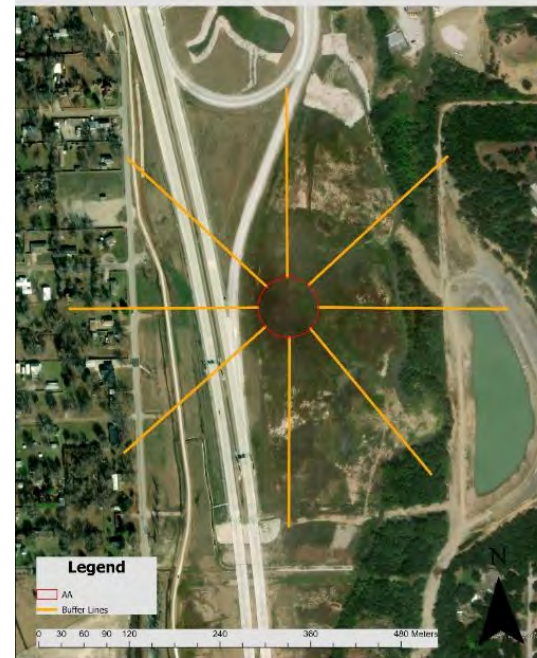
Site 2 Assessment Review: Buffer Filter

All buffer transects immediately intersect mowed lawn and the site scores 0 for Buffer Filter

All transects are > 30 m from low impact and >100 m from moderate impact. The site scores 1 for Buffer Filter.

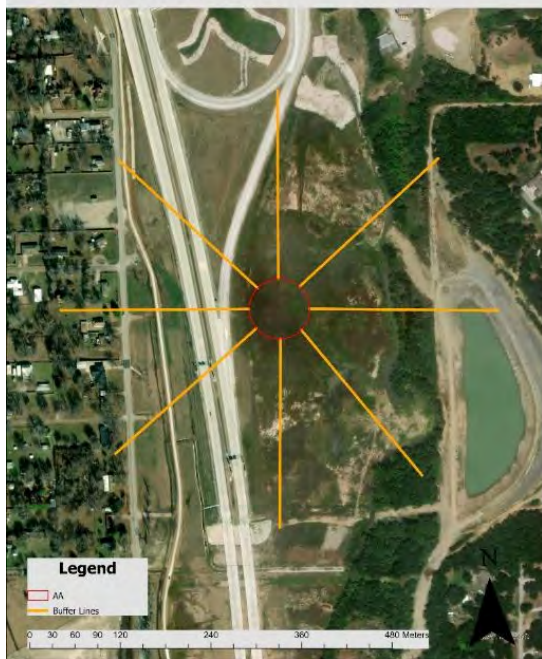
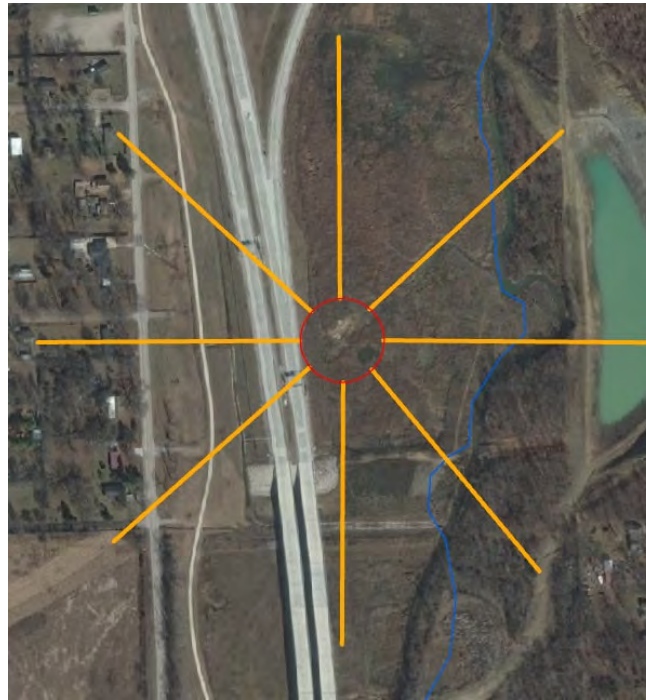
Wetland 2: Buffer Lines

- Location within AA matters
- Moving AA could result in a Buffer Filter score of 0.68
- Larger wetlands tend to score better
- Multiple AAs provide average condition

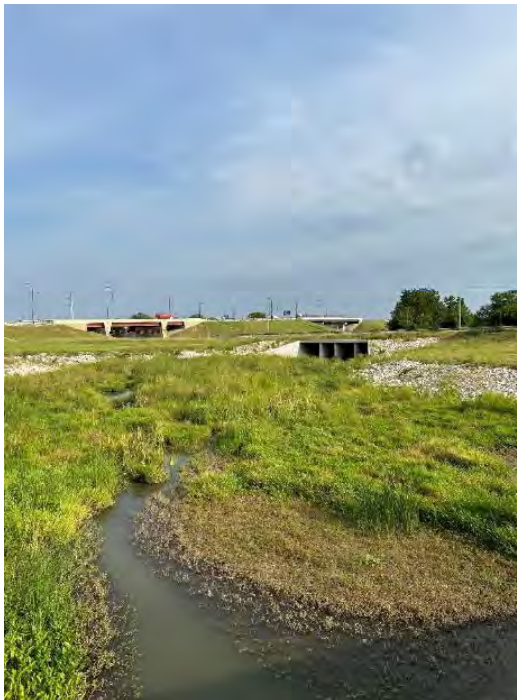
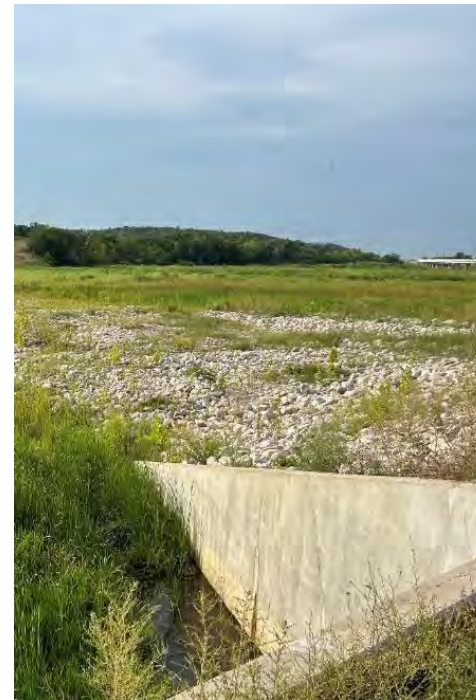
Site 2 Assessment Review: Vegetation Condition

Site 1
minimal
alteration
from rip-rap
around
boundary
and cattails.
Site scores a
0.79

Site 2 has
diversity
strongly
impacted by
lack of trees
and cattail
monoculture.
Site scores a
0.33

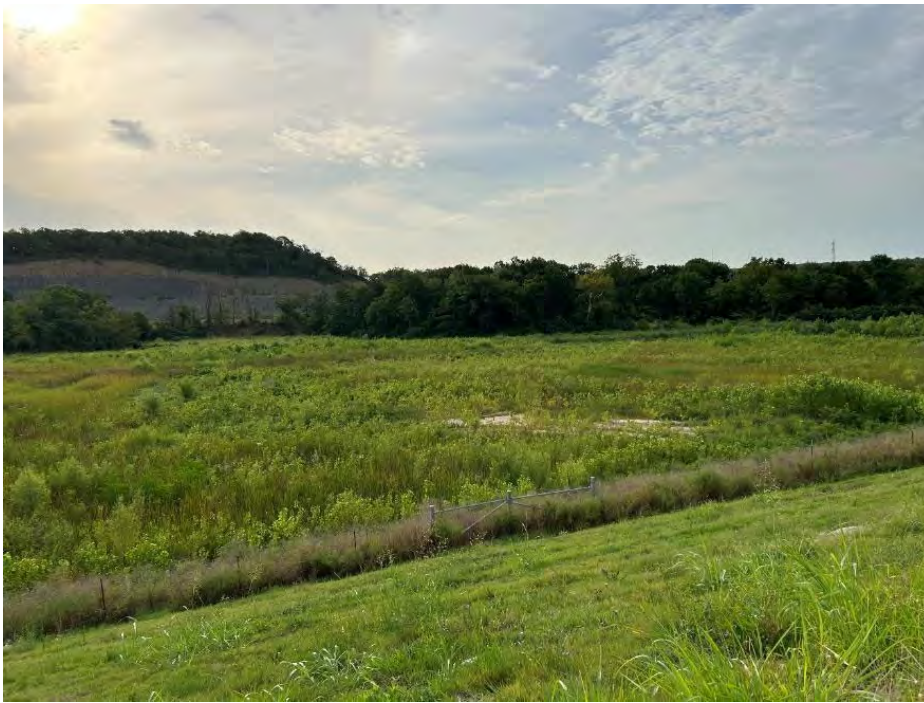
Site 2 Assessment Review: Vegetation Condition

- Need to consider the surrounding wetland context
- Considering the entire wetland on a trajectory towards reforestation would increase score
- Multiple AAs provide average condition

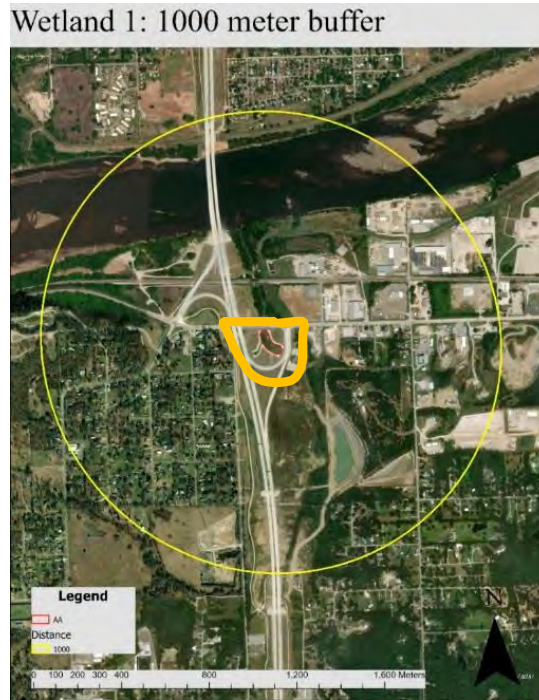
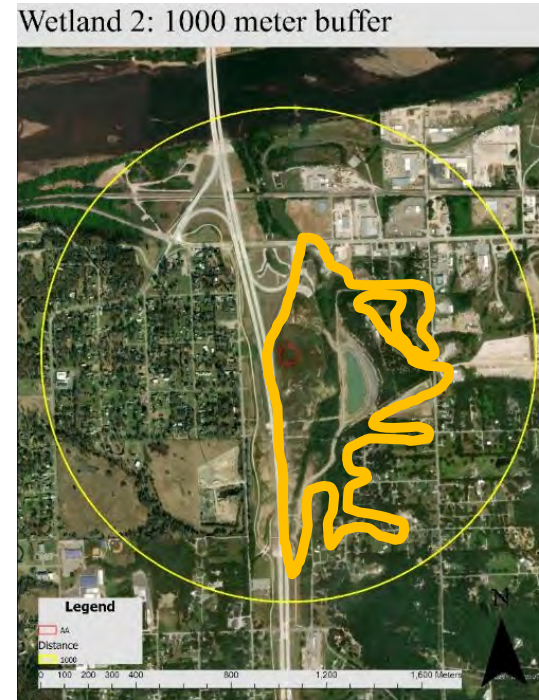
Site 2 Assessment Review: Habitat Connectivity

Site 1 has no connectivity due to surrounding turnpike and scores a 0.

Site 2 has greater connectivity due to larger wetland size and adjacent natural uplands and scores a 0.15.

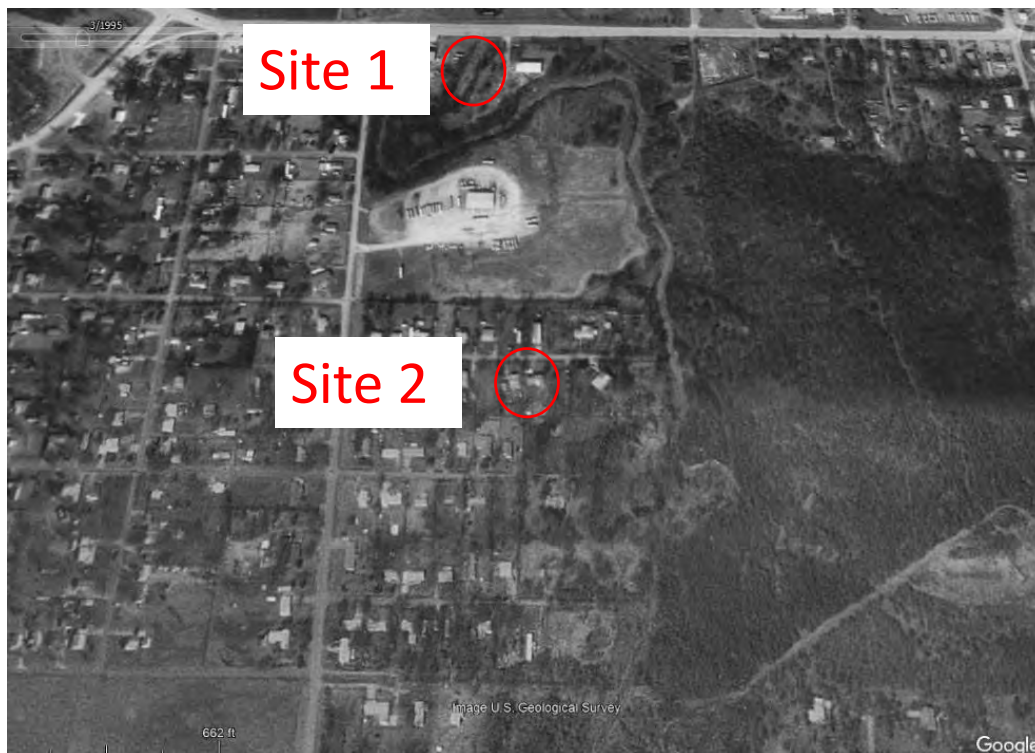
Historic vs. Current: Pre-restoration

- Given location constraints and stormwater role, Site 1 provides wetland functions. However, minimal uplift opportunity from 1995 condition.
- Uplift potential for Site 2 is very high, essentially from a non-wetland site in 1995 which should score close to 0.0

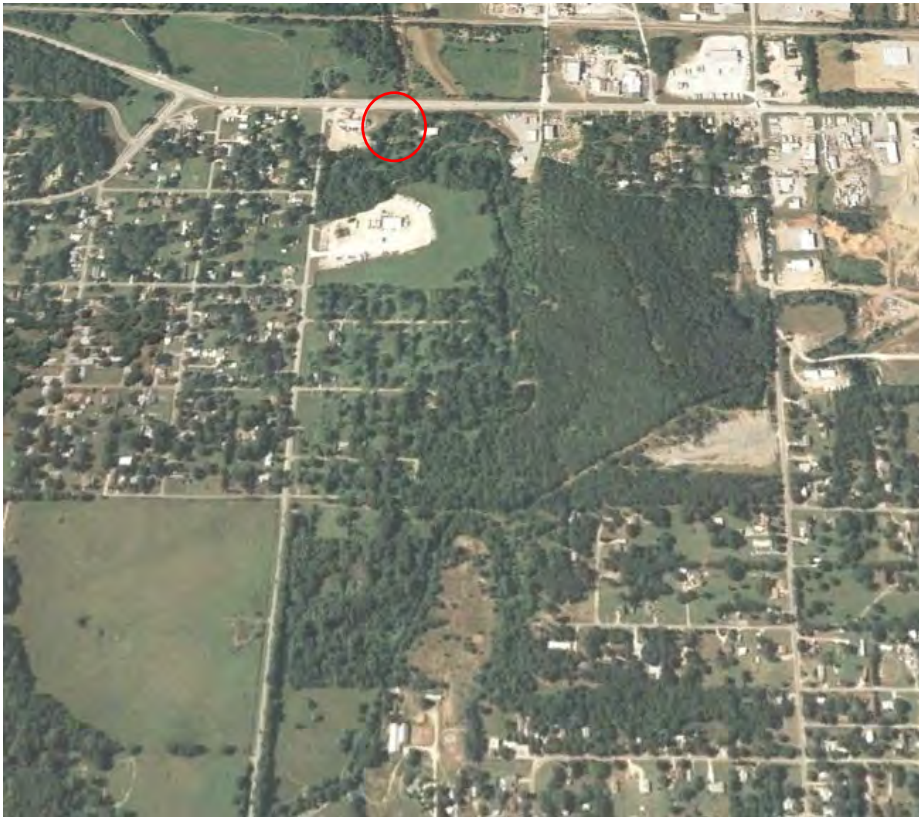
Historic vs. Current: Site 1 Hypothetical Pre-restoration

Metric	Score
1 Hydrology	
1a. Hydroperiod	1
1b. Water source	0.58
1c. Hydrologic Connectivity	0.75
Hydrology Attribute	0.77
<i>(metric 1a + metric 1b + metric 1c)/3</i>	
2 Water Quality	
2a. Nutrients/Contaminants	0.50
2b. Buffer Filter	0.25
Water Quality Attribute	0.38
<i>(metric 2a + metric 2b)/2</i>	
3 Biota	
3a. Vegetation	0.79
3b. Habitat Connectivity	0.15
Biota Attribute	0.47
<i>(metric 3a + metric 3b)/2</i>	
Overall Condition Score	0.54

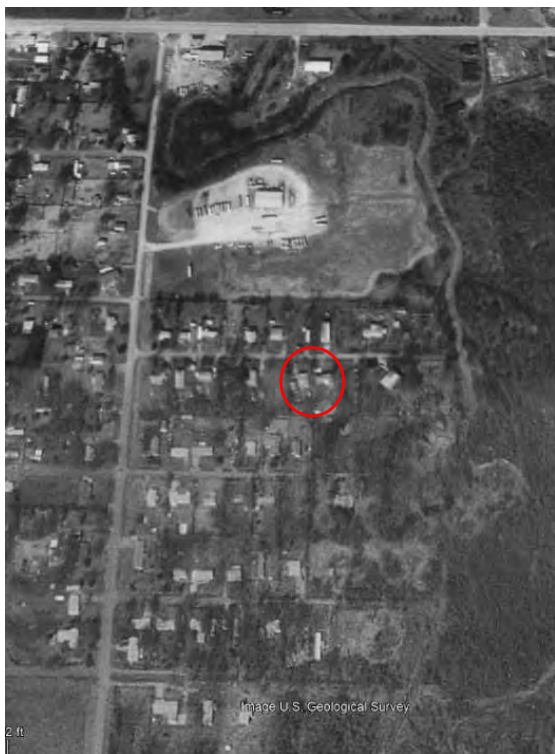
Historic vs. Current: Site 2 Hypothetical Pre-restoration

Hydroperiod = 0 (not a wetland- no hydrology)

Water Source = 0.58 (same as post- same watershed)

Connectivity = 0 (not a wetland- no hydrology)

Pre- restoration score = 0.06

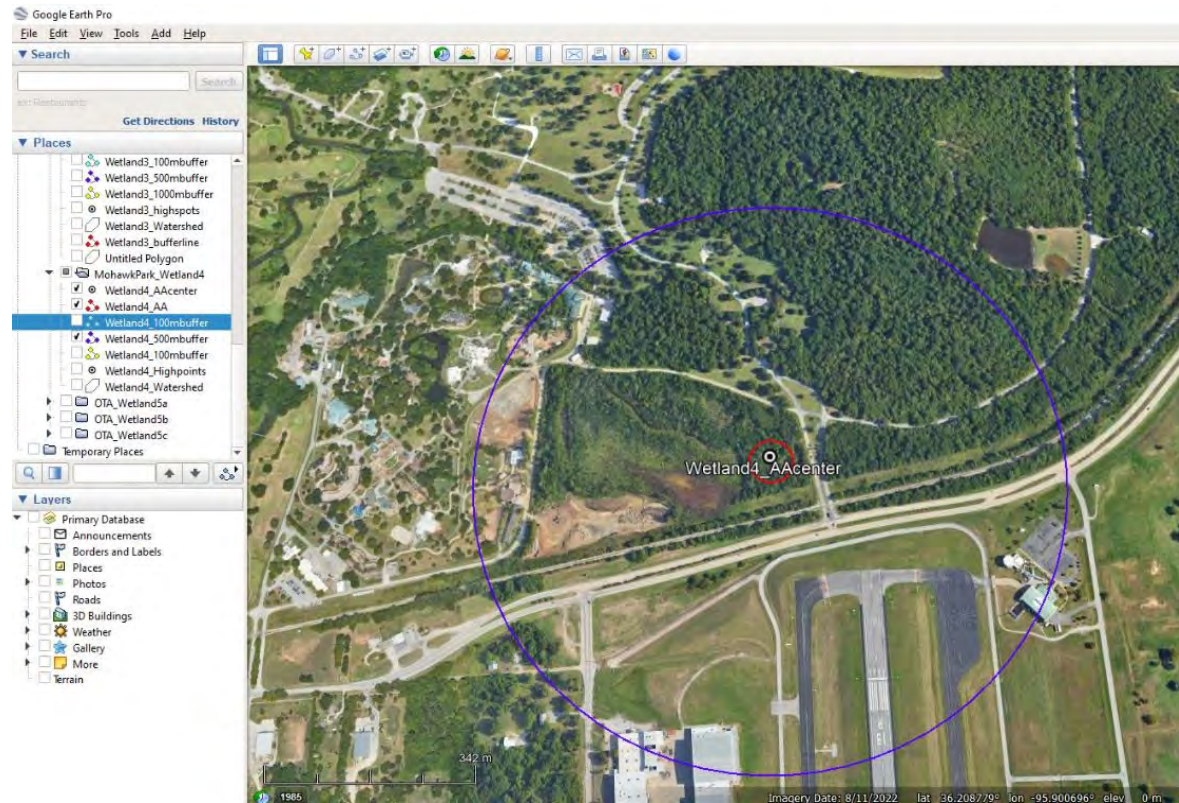
Mohawk4: Hydrologic Connectivity

- ❑ Wetland entirely surrounded by road and railroad grades

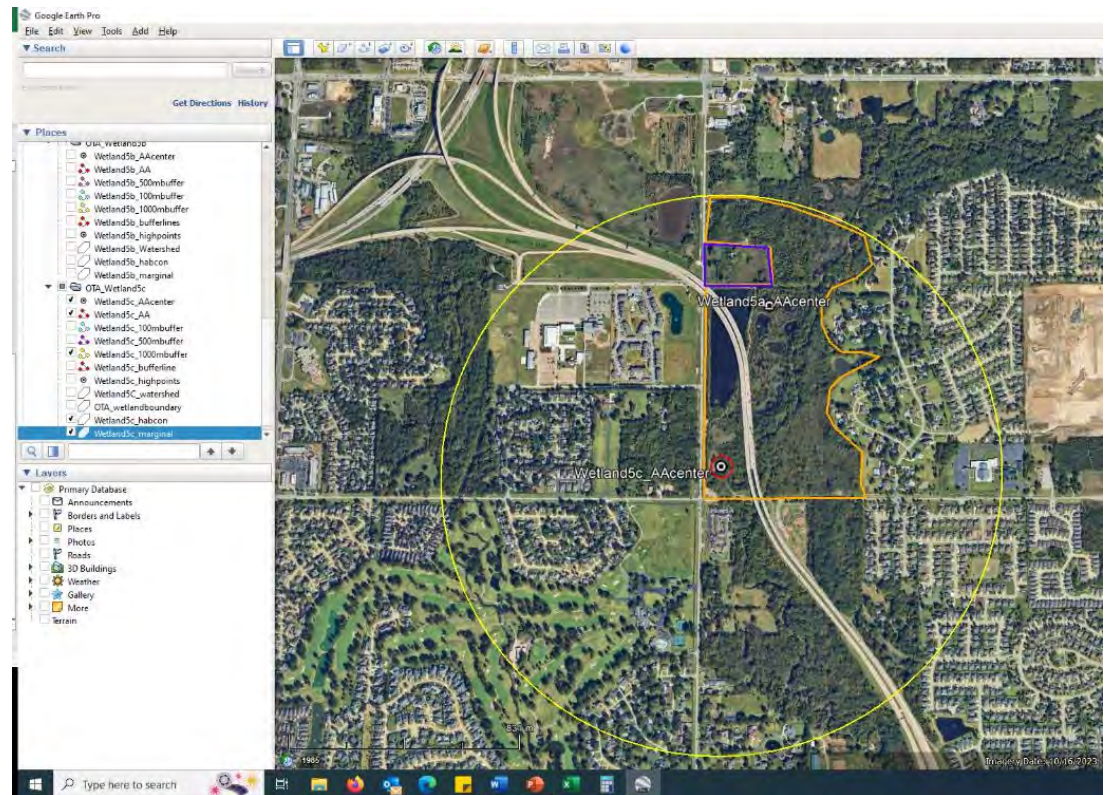
OTA5c: Habitat Connectivity

- ❑ 55 connected natural hectares
- ❑ 60 connected marginal and natural hectares
- ❑ 339 total hectares
